# Manhole Inspection Summary

Manhole # S35I\_\_024MH

**Location** Address: **1 spratt st**

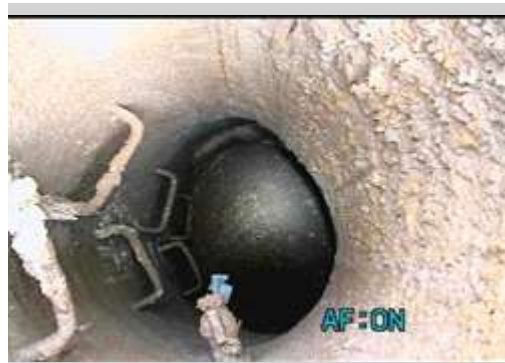
Top View

12 is tucked back hard to see from top view

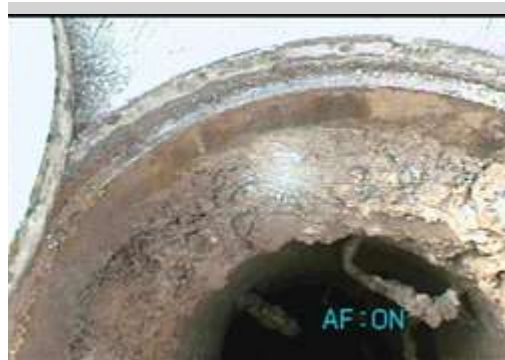
Defect 2

Offset: **3.5** (in.)

Infiltration: ☐ None ☒ **Joint** ☐ Cracks ☐ Mortar ☐ Roots ☐ Wall

corbel infiltration joint, offset

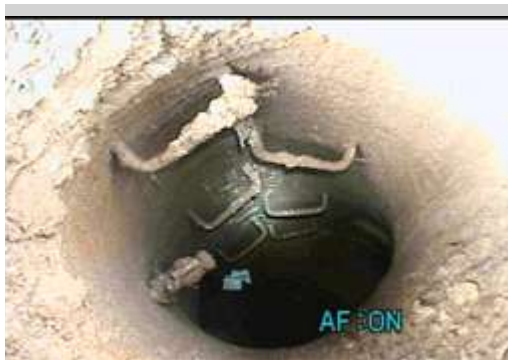
Defect 1

Count: **6** Missing: **0** ☒ **Corroded**

corr steps
